# Manhole Inspection Summary

Manhole # S33M1\_003MH

Insp Date: **4/12/09 1:57 PM**

**Location** Address: **3000 Potee St.**

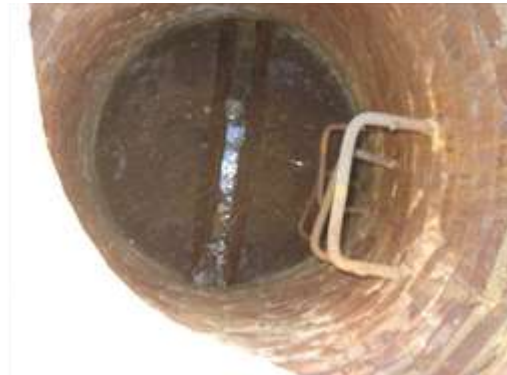
Top View

Condition: ☐ Sound ☐ Cracked ☐ Root Intrusion ☒ **Loose Brick** ☐ Deteriorated

Infiltration: ☐ None ☐ Joint ☒ **Cracks** ☐ Mortar ☐ Roots ☐ Wall

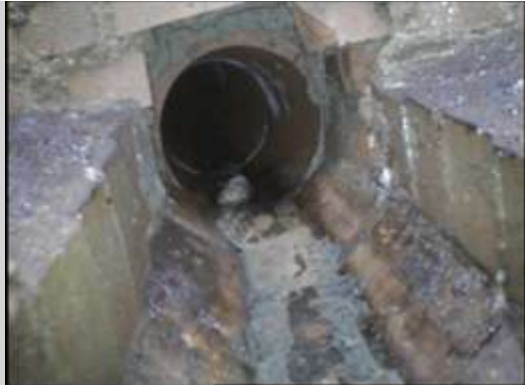
12 O'Clock Outflow

8 in. Circular Gravity Sewer  
Pipe Out @ 12 O'Clock

Pipe Height: **10.8** (in.) Rod and Bar (Angled)  
Pipe Material: **Clay** ☐ Pipe Lined  
Invert Depth: **8.45** (ft.) Flow Characteristics: **Slow**  
Deposits: ☒ None ☐ Mud ☐ Sludge ☐ Debris ☐ Grease  
Silt Depth: (in.) Deposits Extent:  
Infiltration: **None** Pipe Seal Cond: **Sound**

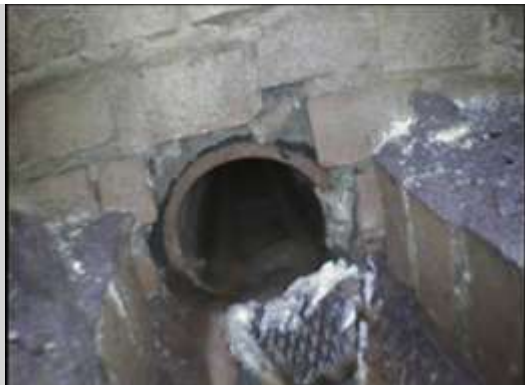
6 O'Clock Inflow

6 in. Circular Gravity Sewer  
Pipe In @ 6 O'Clock

Pipe Height: **7.2** (in.) Rod and Bar (Angled)  
Pipe Material: **Clay** ☐ Pipe Lined  
Invert Depth: **8.50** (ft.) Flow Characteristics: **Slow**  
Deposits: ☒ None ☐ Mud ☐ Sludge ☐ Debris ☐ Grease  
Silt Depth: (in.) Deposits Extent:  
Infiltration: **None** Pipe Seal Cond: **Sound**
